### Project Summary

In 2004, the Cachuma Operations and Maintenance Board (COMB) raised Bradbury Dam (Santa Barbara County, CA) causing the elevation of Cachuma Lake to raise by 3 feet during surcharge events. 879 Coast Live Oak (*Quercus agrifolia*) and Valley Oak (*Quercus lobata*) trees (approximately 90% and 10%, respectively) were drowned by the rising waters, and another 1,122 were at-risk totaling 2,001 trees. At a 2 to 1 mitigation ratio with a 18% mortality rate as determined at the end of the first ten years of the program, 4,722 replacement trees are needed to achieve our mitigation target by 2025 when the planted oak trees need to be self-staining. Described are the mitigation process and success of the program from 2005 through 2017.

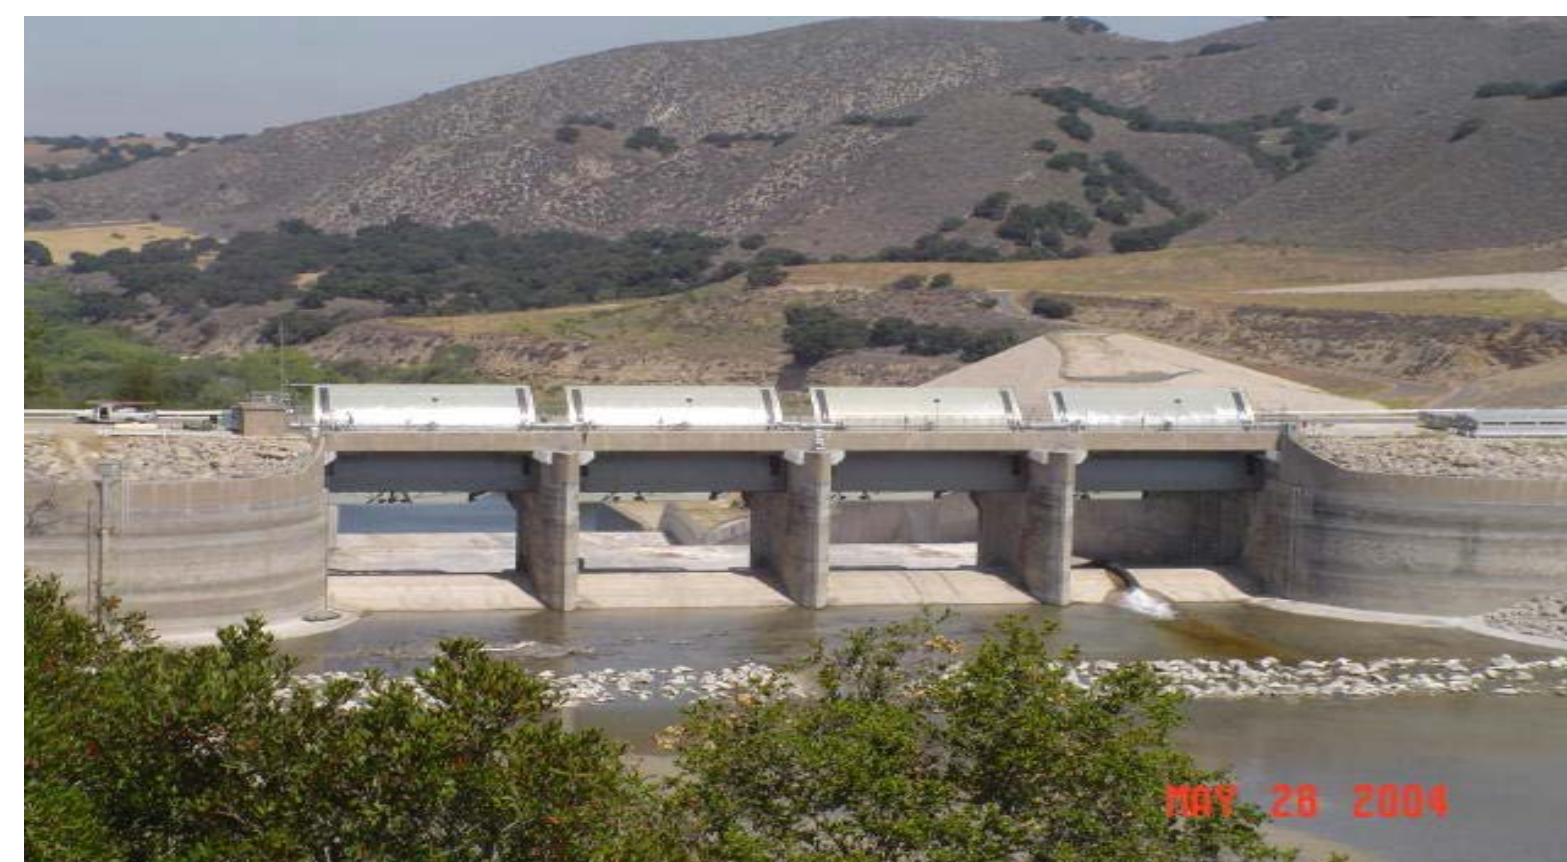
Bradbury Dam with all four radial gates open and the 4-foot flashboards on top

In 2004, U. S. Bureau of Reclamation (USBR) in collaboration with COMB installed 4 foot high flash boards on top of the radial gates of Bradbury Dam to enable surcharging of Lake Cachuma by 3 feet or 9,200 acre-feet of additional water storage to be used in support of the federally listed endangered southern California Steelhead (*Oncorhynchus mykiss*, *O. mykiss*) downstream of the dam. Specifically, the extra storage is used for water releases to the Santa Ynez River and adjacent Hilton Creek in support of the fishery in the Lower Santa Ynez River basin for rearing and fish passage. Higher lake levels impacted the oak trees near the lakeshore resulting in a new program to mitigate for the lost and at-risk oak trees. The Lake Cachuma Oak Tree Restoration Program started in 2005 with mitigation targets set ten years into the program through a Lakeshore Survey which will be completed by 2025.

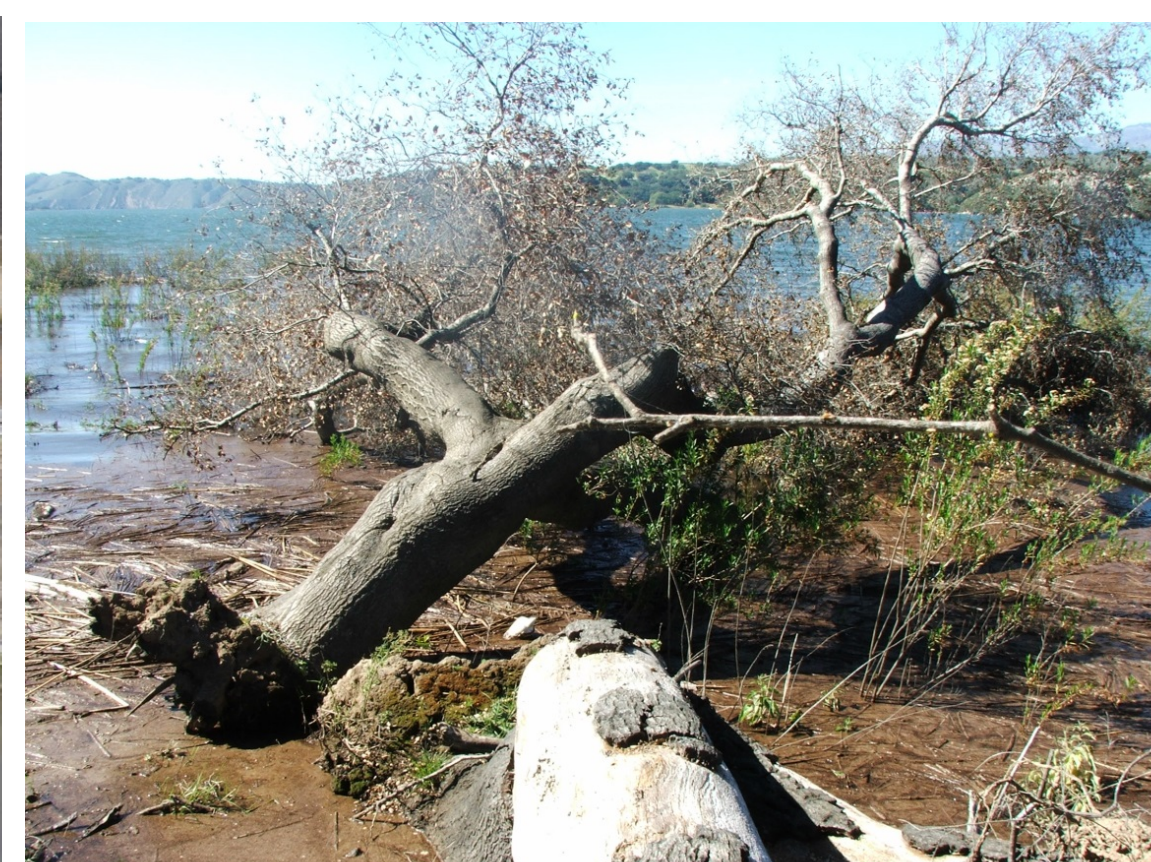
Impacted oak trees on the lakeshore

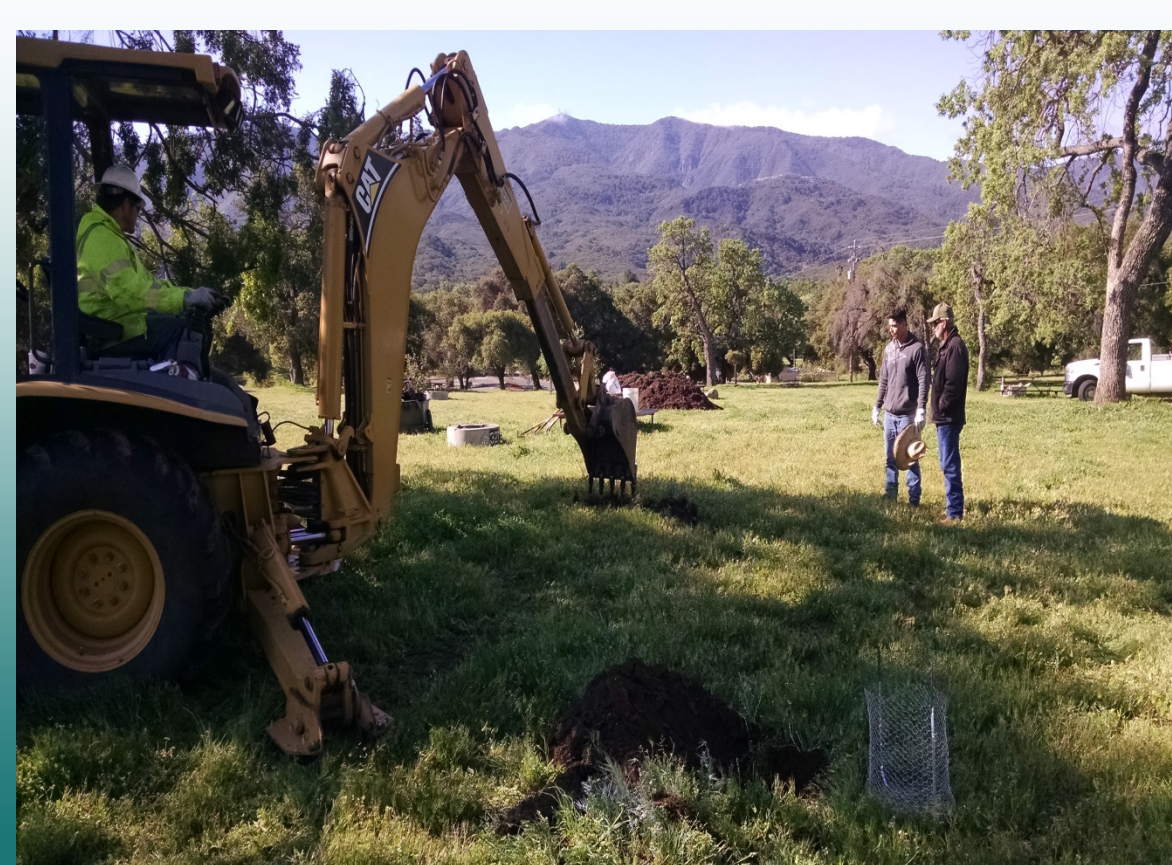
Use of a backhoe to dig rough holes for planting with a professional gopher cage.

- Use backhoe dug holes instead of auger dug holes to best allow root spread.
- Use local acorn stock for nursery grown trees; it's best to have program staff collect the acorns for nursery propagation.

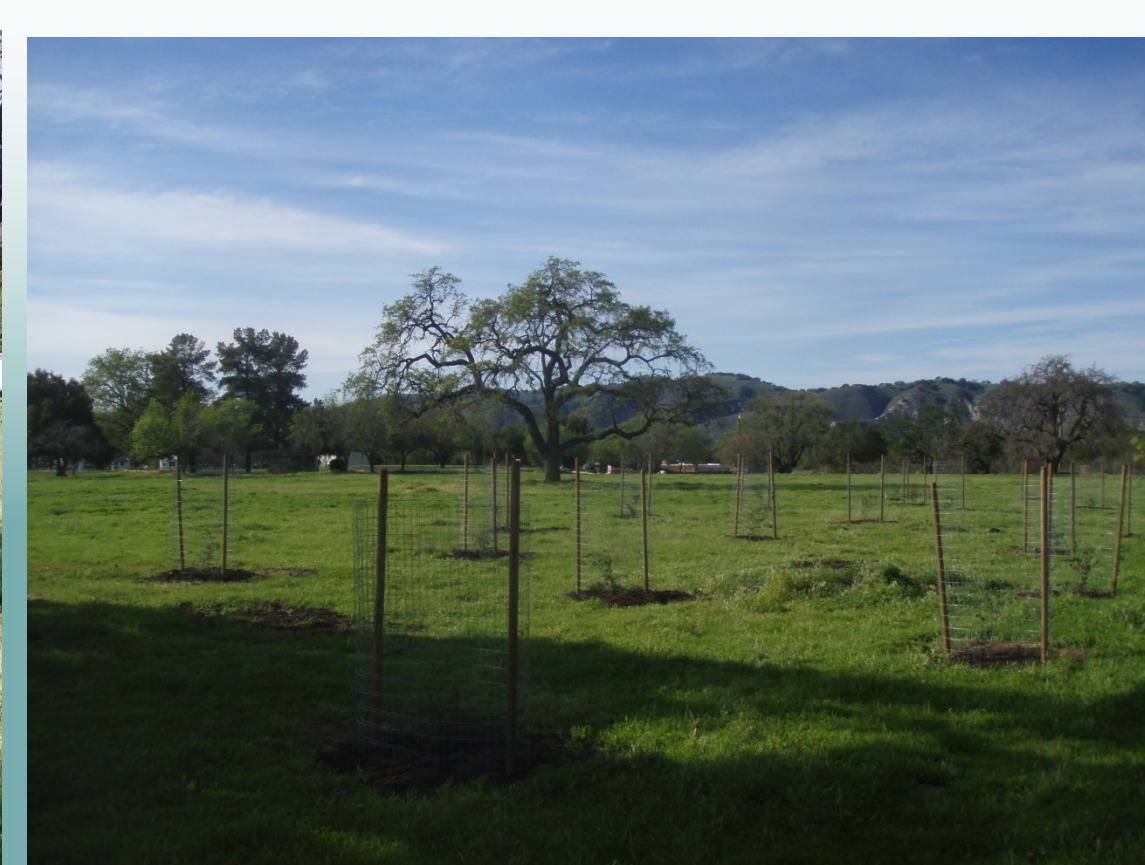
Trees planted at least 25 feet apart.

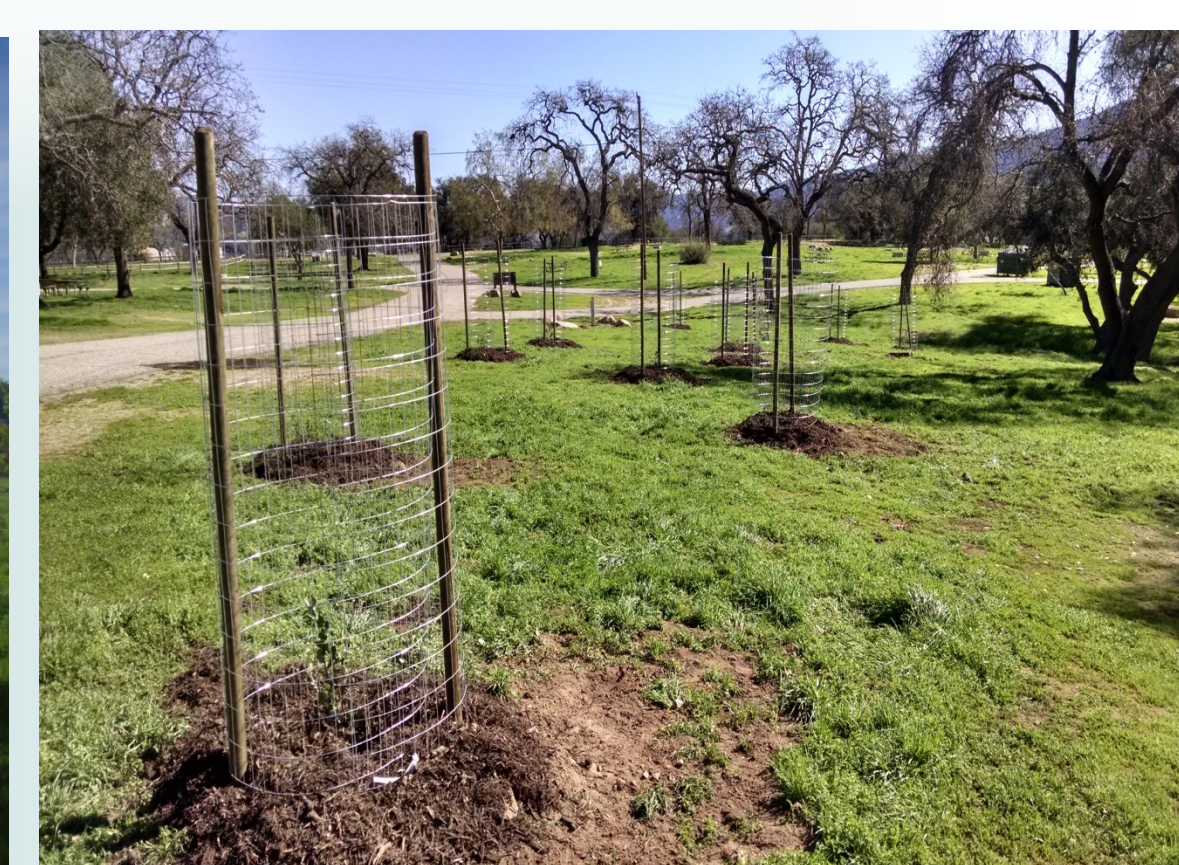
Trees are protected with 5 foot high deer fencing and thoroughly mulched.

- Conduct systematic mulching of all trees once a year, particularly newly planted trees for soil enhancement and moisture protection.
- Use 4 or 5 foot welded steel field fencing versus nettings for deer cages to prevent deer browsing and avoid entrapment of snakes.

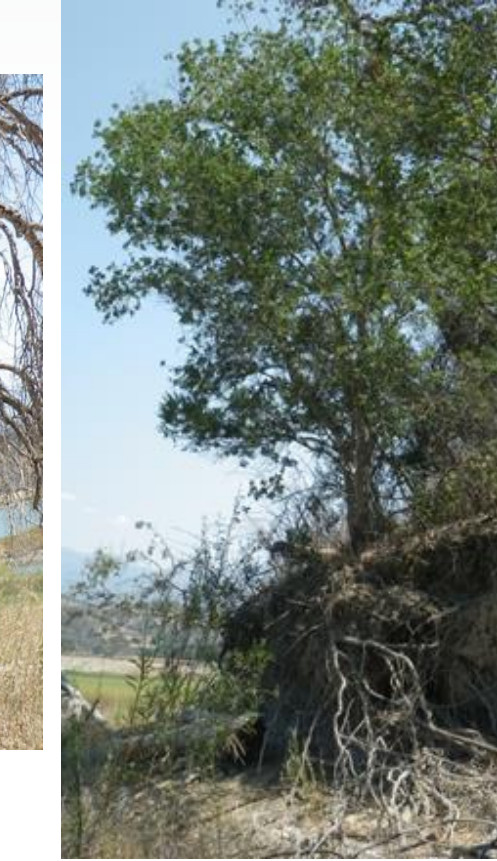
Impacted oak tree roots

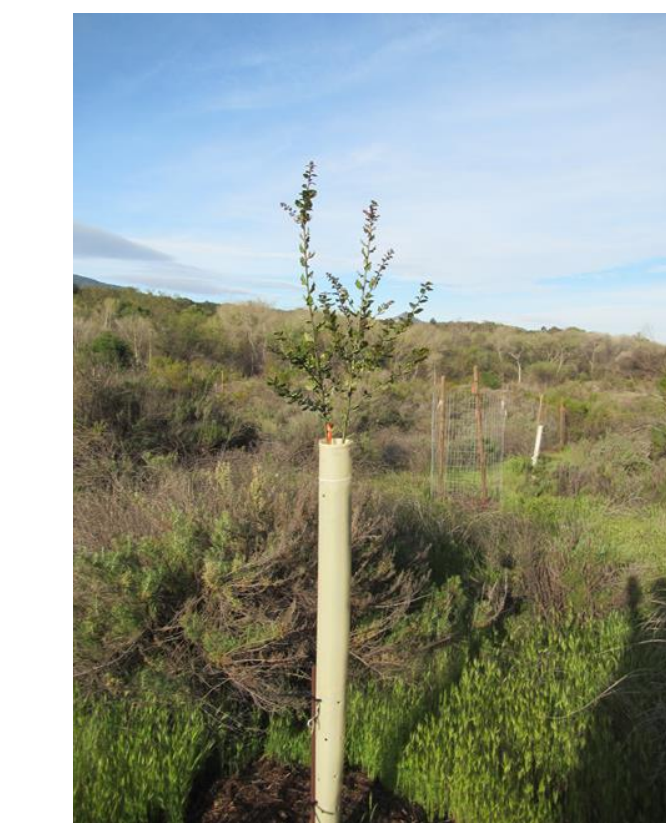
Use of Gro-tubes act as mini-greenhouses and rodent protection

- Gro-Tubes provide a localized greenhouse effect for auto-irrigation, protection against surface rodents, and encourage taller, faster oak tree growth.

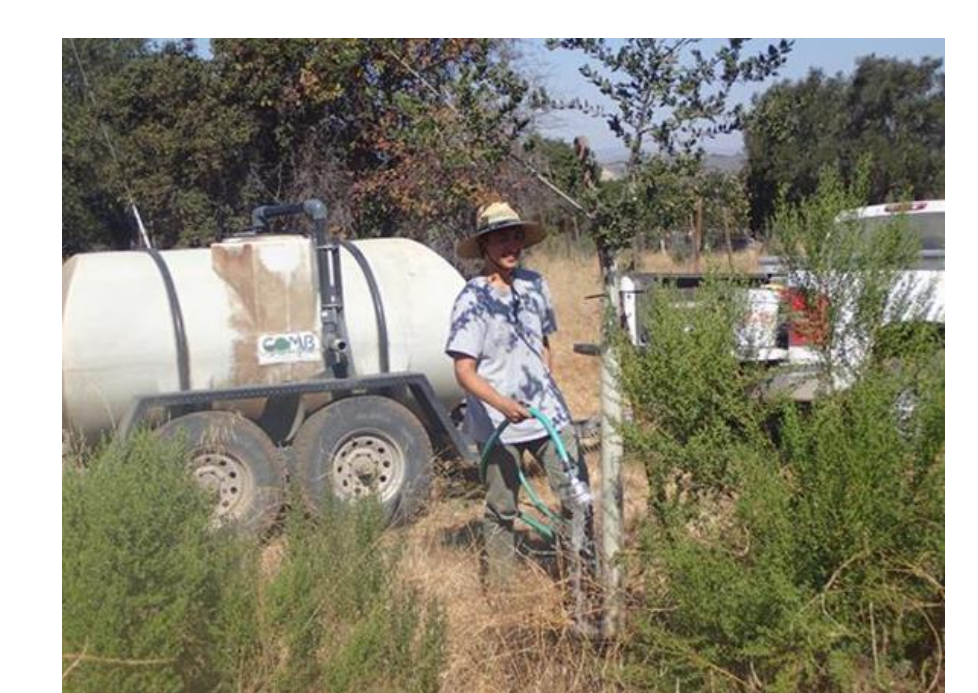
Watering with 1,000 gallon water trailer

- Irrigate trees at least once a month during the dry season until the trees are established, necessary for survival.
- During extensive periods of drought, irrigating can be necessary year round.

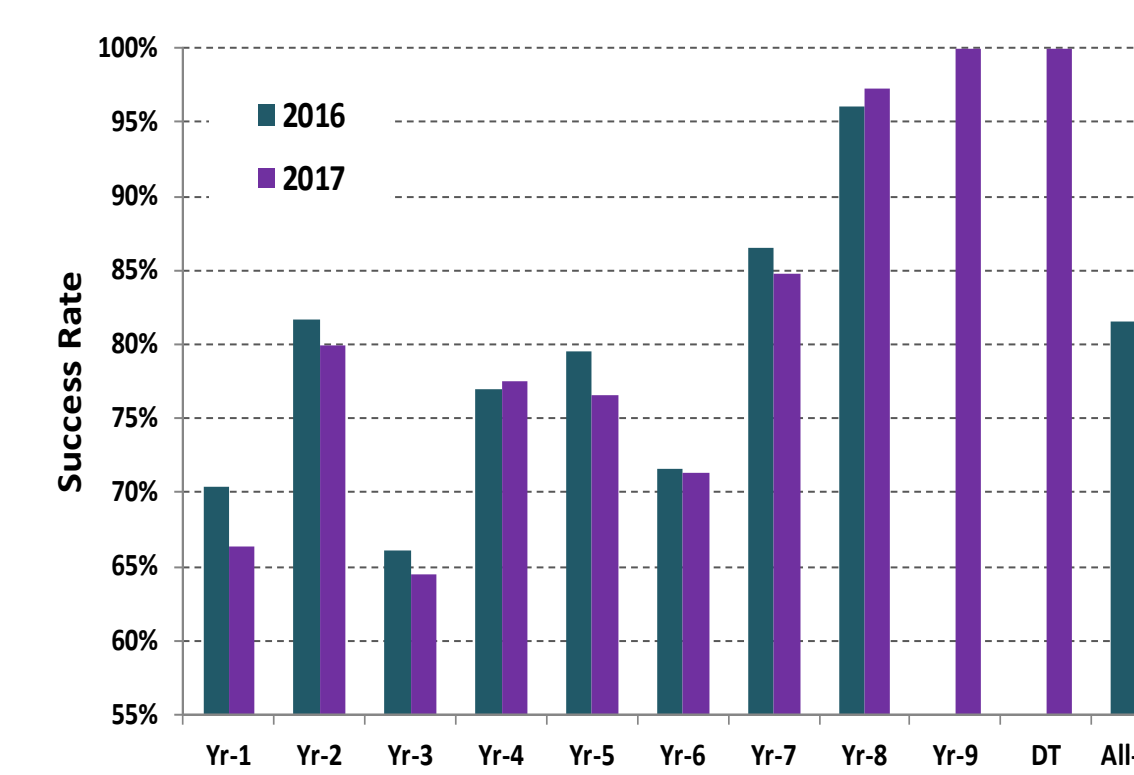
Success rate comparison from 2016 to 2017 for each and all tree years (Yr)

3,674 oak trees are alive as of December 31, 2017, the survival rate is 82.21%, and the remaining 1,047 trees will be planted within the next couple of years.

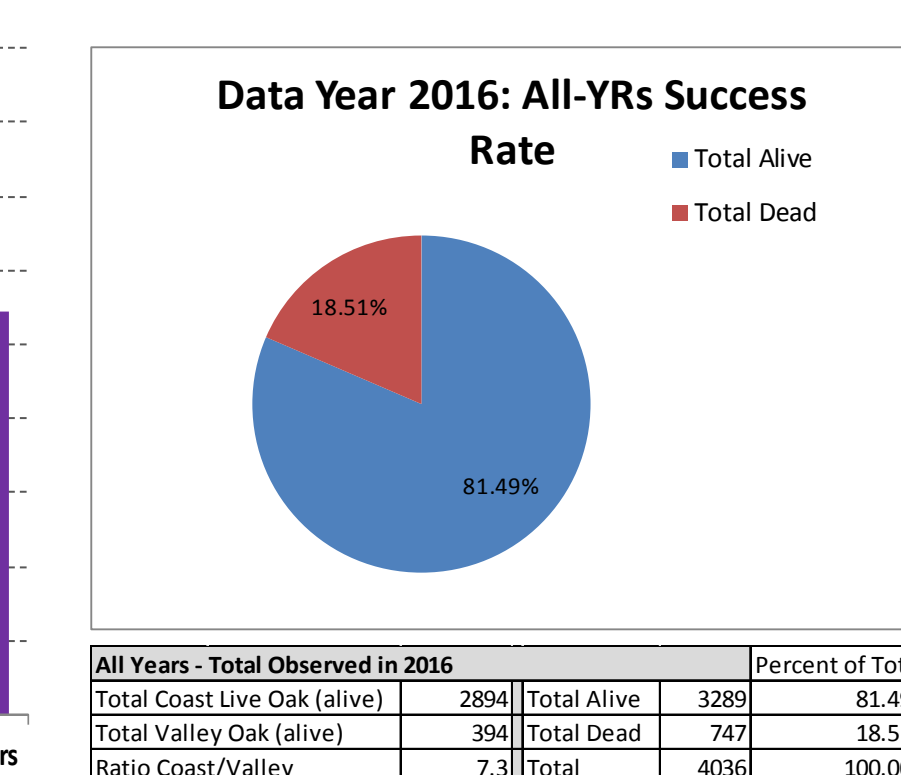
Result comparison between 2016 and 2017 for all year of planted trees.
